## Analyses of the plastic deformation of coated conductors deconstructed from ultra-high field test coils

To cite this article: Xinbo Hu *et al* 2020 *Supercond. Sci. Technol.* **33** 095012

# Analyses of the plastic deformation of coated conductors deconstructed from ultra-high field test coils

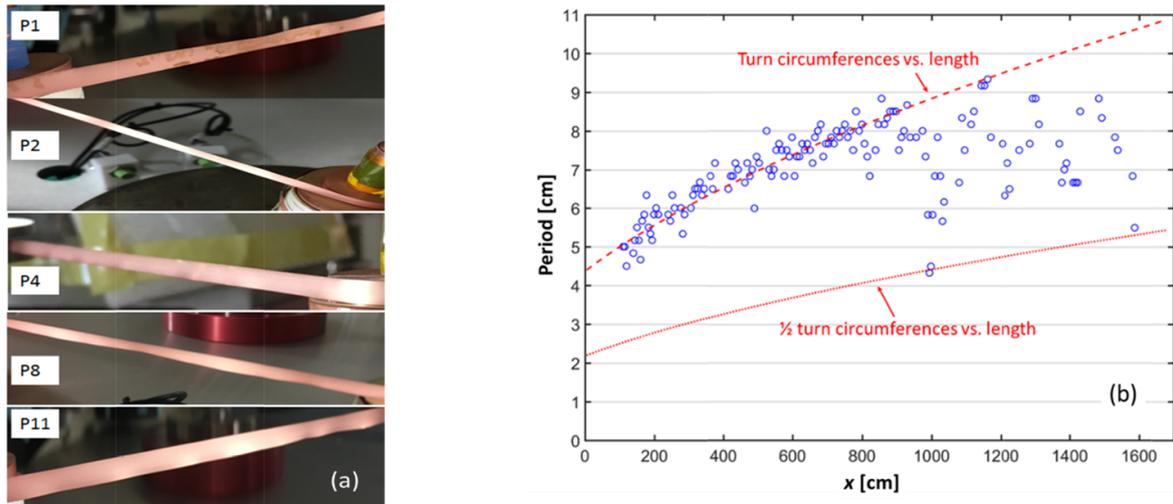
Figure 1(a) shows photos of the evident rippling on one edge in unwound sections of tapes from LBC2 after test. The rippled edge is on the top for P1, P2, and at the bottom for P8 and P11, that is the edge pointing toward the coil end in each case. The rippling on P4 is less obvious and only exists on the bottom edge of the very outermost turns. Because so localized, it may be associated with proximity to the outer solder joint. The ripple period is defined by the image of P8 in the picture. Figure 1(b) shows the ripple period versus position along the tape length from inner to outer turns for P1. The fit line depicts the radially-varying circumferences of inner to outer turns and gives the tape thickness as  $\sim 48 \mu\text{m}$ , very close to the manufacturer's specification of  $45 \pm 4.5 \mu\text{m}$ . The periods match the circumferences for the inner and middle turns but the period drops and becomes more random for outer turns with radius larger than 14 mm.

**Figure 1.** (a) Photos of short conductor lengths with one rippled edge unwound from the pancakes. The ripple period is marked by the double-headed arrow on P8. (b) Ripple period versus tape position from the inner to the outer turns of P1, LBC2. The fitting line is the circumference of inner to outer turns versus tape position. The tape thickness fit is  $48 \mu\text{m}$ , which is consistent with the manufacturer's  $45 \pm 4.5 \mu\text{m}$  specification. It can be seen that the ripple period is quite accurately the circumference up to  $\sim 900 \text{ cm}$  tape length but it becomes shorter and more variable for the outer turns.

Figure 1 shows that one obvious result of our *post mortem* investigation is that some pancakes were significantly and inhomogeneously plastically deformed by energization or by the subsequent quench. Figure 10 shows the 77 K stress–strain curves of two samples of the as-received tapes made with an attached extensometer, both giving identical results within the experimental points. The first yield event occurs at  $\sim 400$  MPa, presumably where the  $\sim 10$   $\mu\text{m}$  of Cu and 4  $\mu\text{m}$  of Ag yields. A definable yield stress of the whole tape occurs at  $\sim 900$  MPa and the 0.2% yield strength occurs at  $\sim 1.02$  GPa. The linearized elastic modulus below 400 MPa is 192 GPa, declining to  $\sim 170$  GPa above the plastic yield regime of Cu and Ag. Based on measurements of other SuperPower tapes we expect the 4 K properties to be 5%–10% higher. By contrast the maximum calculated transport current hoop stress  $JBR$  was 750 MPa which occurs in P10 of LBC3, values which are clearly not high enough to plastically deform the Hastelloy, leading us to conclude that there must be additional stresses to cause the observed plastic deformation damage.

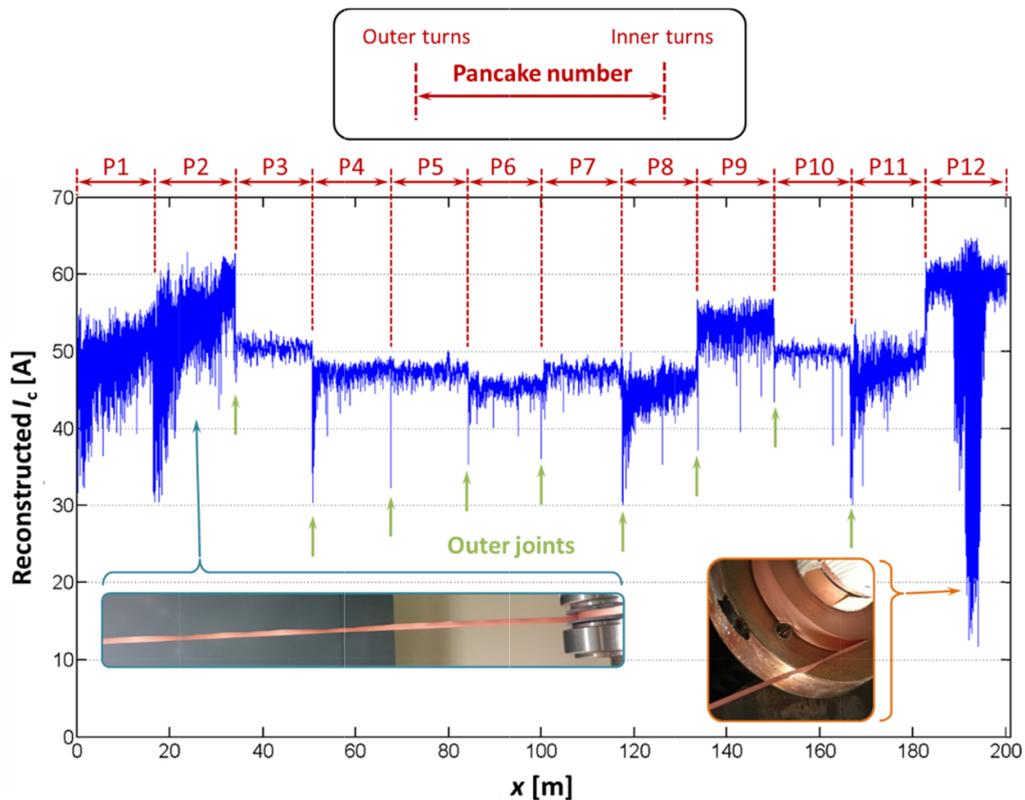
Figure 2 shows the position dependence of  $I_c$  (77 K) of the tapes unwound from the LBC2 coil. In this case, because of the damage suffered by the tape, we preferred to avoid direct transport measurement and to deduce  $I_c$  values from the non-contact Hall probe array signal which was scaled to the transport  $I_c$  measured with  $B \parallel c$ , 0.6 T. The left ends of  $I_c(x)$  always correspond to the outer diameters of the pancakes. The degradations on the outer turns of P1, P2, P8, and P11 are related to rippling of the tapes, which all occur on the outer edges. The degradation of P4 is relatively smaller compared to the above pancakes. The  $I_c$  drops at the left end of each tape occur at the joints that connect the pancakes. The tape of the bottom pancake, P12, was damaged by a mounting screw that inadvertently penetrated into the winding during assembly. No other degradations were observed.

**Figure 2.** Position dependence of  $I_c$  (77 K) of the tapes after coil test which ended with one quench at 42.5 T. The reconstructed  $I_c$  derived from the Hall probe array is scaled to the transport  $I_c$  measured at  $B||c$ , 0.6 T. The tapes are connected in series from outer to inner turns. The sharp drops at pancake transitions are due to the degradation of the outer joints of the coil.

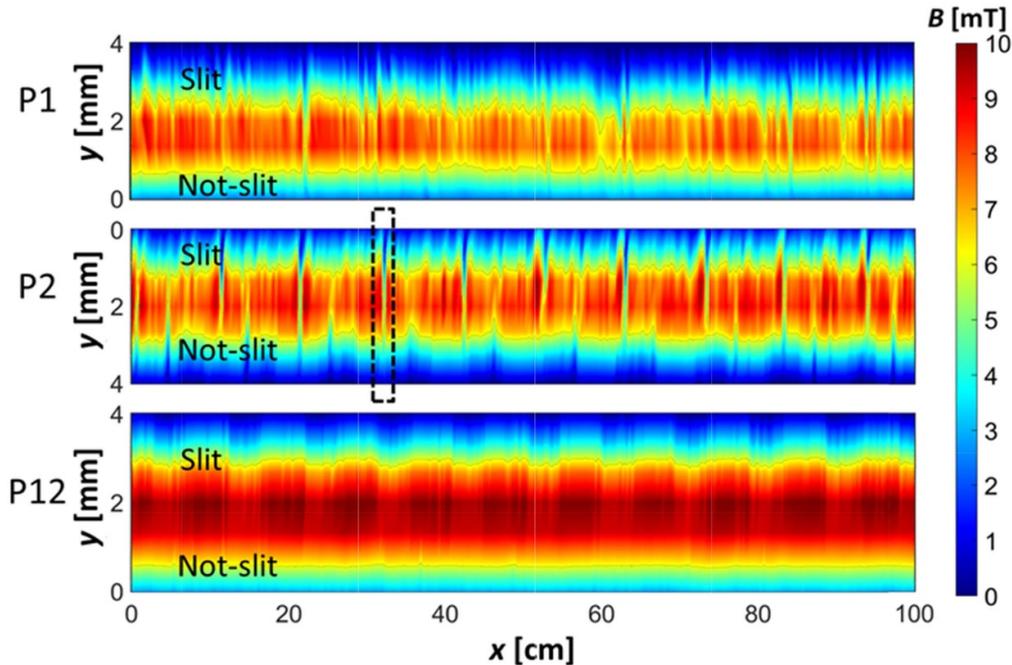
Figure 3 shows 2D Hall magnetization maps that are quite non-uniform across 1 m lengths of the outer turns of P1 and P2 of LBC2. As a comparison, the inner turns of P12 has no obvious degradation and is relatively uniform. Many longitudinal drops in the signal are seen which correspond to cracking damage that we associate with excessive hoop strains. The maps clearly show more damage on the outer tape edges, which are also the slit edges, particularly for P1. For P2, there are apparent periodic degradations, whose period matches the circumferences of the outer turns. Although P1 presents similar transverse defects as P2, the periodicity is not so obvious and the degradation is more generally severe.

**Figure 3.** Two-dimensional magnetization maps of 1 m lengths of the outer turns of pancakes P1, P2 and the inner turns of P12 of LBC2. P12 was wound with tape from the same production run as that of P1 and P2 but has no obvious degradation. The dashed rectangular box is the region cut out for magneto-optical imaging in figure 4. Evident transverse damage is present in both P1 and P2 tapes but is much less obvious in P12.

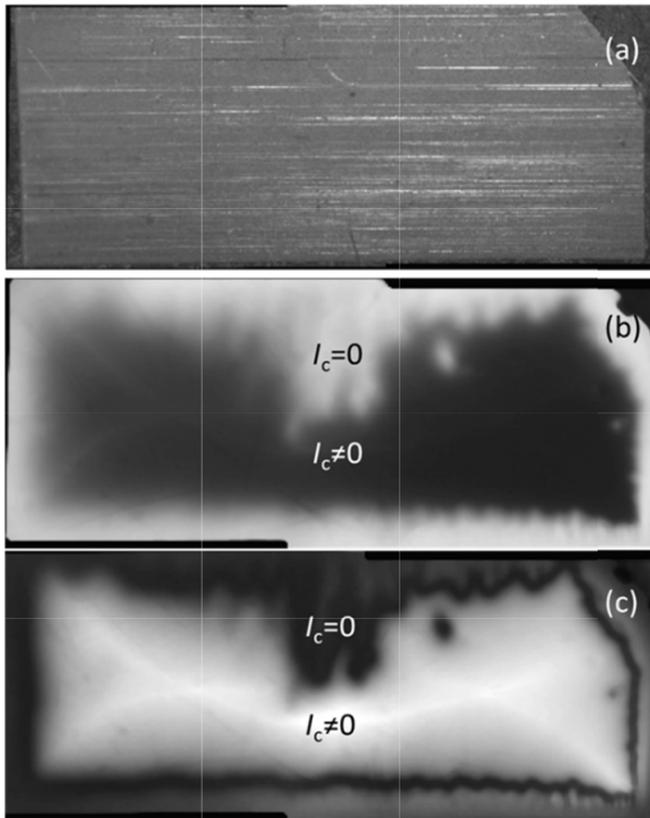
To better visualize the superconducting impact of the periodic damage of P2, a 10 mm long piece (the dashed rectangle in figure 3) was cut out for MOI and SEM. Figure 4(a) shows the light image, while (b) and (c) show the polarized light MO images (taken at 10 K, 120 mT after ZFC and 0 mT after FC in 120 mT, respectively). The degraded and superconducting regions are indicated in the images. The rough upper

edge of the sample indicates more damage than on the lower edge. A major defect penetrating about half the tape width is visible in the middle of the image. The Cu and Ag layers were then etched away to allow direct inspection of the REBCO layer itself by SEM. Figures 5(a) and (b) show top views of the upper and lower edges, which confirm that the irregular flux penetration of figure 4 occurs preferentially at the slit edge. The oblique curved cracks produced by slitting penetrate 20–25  $\mu\text{m}$  from the edge but are about three times longer (see figures 5(a) and (c)). In some places, the buffer layer is exposed and delaminated REBCO is observed at the edge (figure 5(a)). It is possible that the delamination between REBCO and the buffer layers is even more extensive than what can be seen in the image, given that the magnetic flux penetration of figure 4(b) occurs to half width of the tape. Longitudinal focused ion beam' bed sections of the damage are also of interest, as in figure 6. In the section made 10  $\mu\text{m}$  away from the slit edge (figure 6(a)), there is an extensive gap between the buffer and the REBCO layer. The much better connection to the Ag cap layer suggests a better adhesion of REBCO to the Ag than to the buffer layer. This observation also suggests that the real extent of delamination damage is not visible from purely topographic imaging of the bare REBCO layer. We conclude that companion MO images are more reliable in assessing the damaged areas because they directly image the fields generated by the induced screening currents of the REBCO layer. Figure 6(b), 15  $\mu\text{m}$  into the layer shows less damage but the layers are still far from perfect. The porous REBCO close to the buffer layers is unlikely to be able to carry supercurrent.

**Figure 4.** (a) Light micrograph image of the piece cut from tape P2 of LBC2 marked in figure 3. (b) The MOI image shows clear evidence of easy flux penetration at multiple places on the upper edge, which reaches approximately half of the tape width in the central region. By contrast the not-slit, lower edge is much more uniform. The upper right diagonal cut was made to mark the slit edge. The image was taken at 10 K in 120 mT perpendicular field after zero-field cooling (ZFC). (c) The corresponding image taken after field cooling (FC) in 120 mT, and then removing field at 10 K.

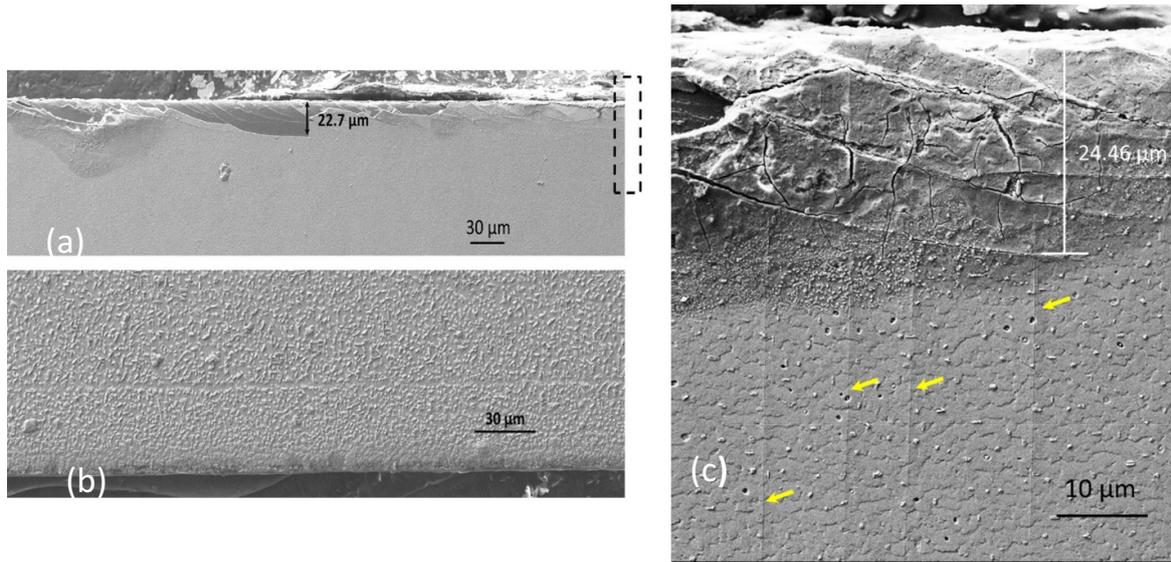
**Figure 5.** (a) and (b), top views of the upper (slit) and lower (not-slit) edge of the sample in figure 4 after removing Cu and Ag. (c) Enlarged view of the box with dashed line in (a). The transverse cracks indicated by the arrows might be caused by stress-concentrations. The slitting cracks (slightly curving cracks at  $\sim 30^\circ$  to the tape edge) can be clearly seen in both the REBCO and buffer layers, and usually extend 20–25  $\mu\text{m}$  in depth from the edge. The not-slit edge presents a large density of  $a$ -axis grains, but no cracks.

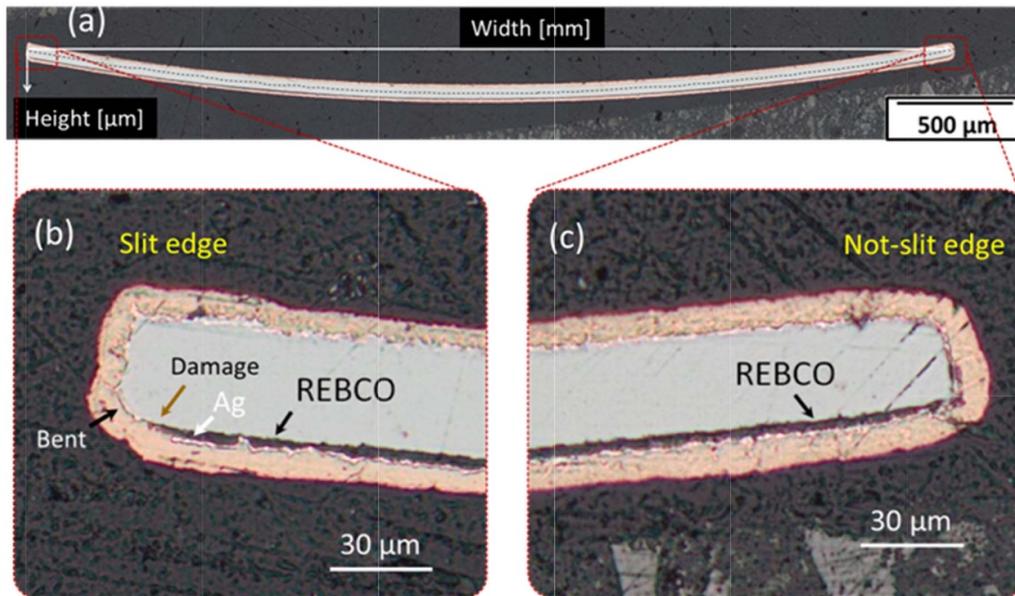
**Figure 7.** (a) Transverse cross-sectional views of the as-received tape and (b) and (c), enlarged views of the two edges. The arrows in (a) illustrate how the width and camber height are defined. The slit edge shown in (b) has REBCO missing over  $\sim 15 \mu\text{m}$  at the very edge, a result of the mechanical slitting during manufacturing.

constricted current flow at artificial defects [28] and by funneling of current between misaligned grains [29] suggests that significantly greater attention needs to be paid to the slitting process used for so many REBCO tapes. Although the damage observed here all occurred during a single test cycle of each coil, it is easy to predict that fatigue conditions could considerably worsen performance. It seems clear that greater attention must be paid to the whole slitting process and perhaps to addressing whether it is possible to enhance the bonding strength of the REBCO to its buffer stack.

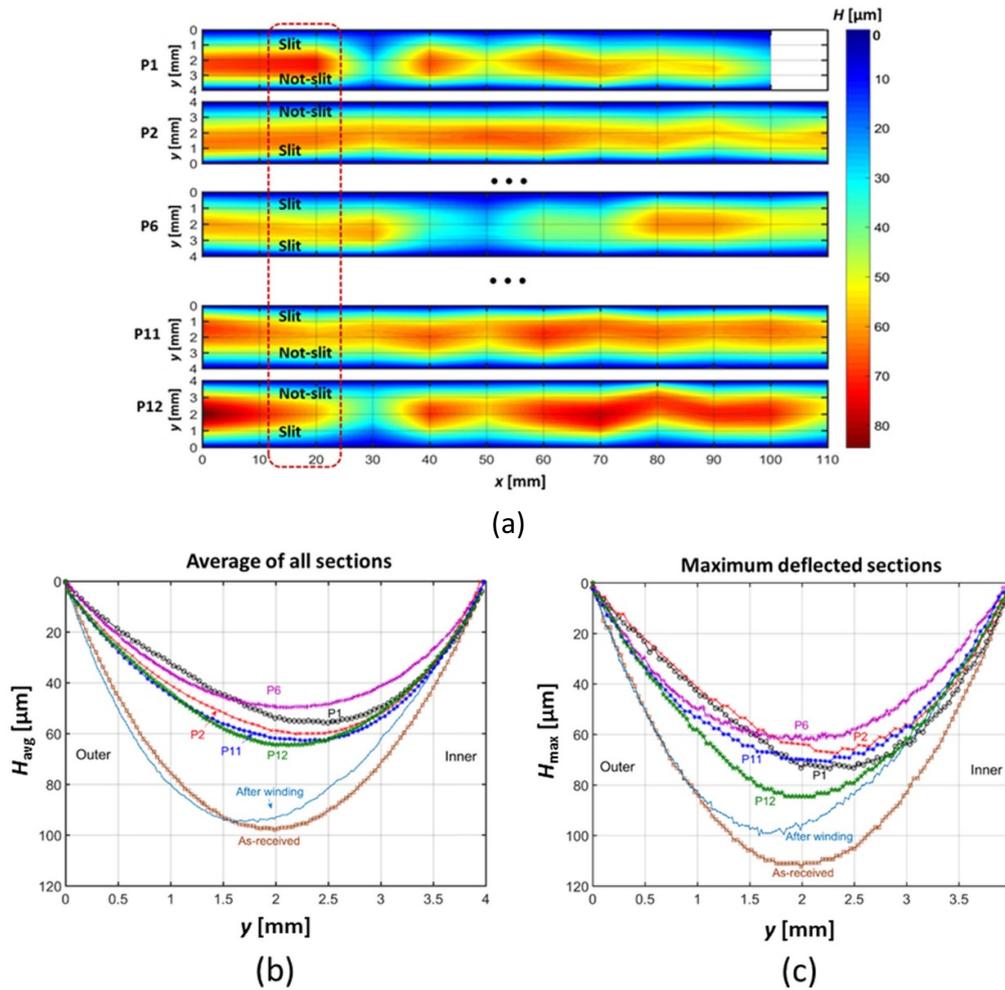
Figure 8(a) shows smoothed height contour maps of  $\sim 110$  mm long tape sections taken from P1, P2, P6, P11 and P12, while figures 8(b) and (c) show camber profiles made using the careful tape cross-section measurements of the type shown in figure 7(a). In these, the outer tape edge (i.e. that facing the end windings) is defined as  $y = 0$  mm. The interval between two cross-sections is about 10 mm, and the height numbers in-between are obtained by linear interpolation in

figure 8(a). It is immediately obvious that the 45.5 T test produced a variable plastic deformation of the tape, represented by a variable tape flattening that varies pancake to pancake and along the length and across the width. Thus the deformation is not azimuthally uniform as is normally assumed. Furthermore

the axis of maximum post-test tape deformation from end pancakes P1, P2, P11 and P12 is not on the geometrical center line of the tapes but shifted toward the edge facing the center of the coil, irrespective of the slit edge orientation. Central pancake P6 has a distinctly more symmetric flattening than

**Figure 8.** (a) Contour map reconstructed from the 10 mm-spaced cross-sectional views. The images were digitized, and the transverse sampling step in the  $y$  direction is about 0.03 mm. (b) Average height and (c) maximum height versus width position. The after-winding sample was cut from a coil never energized. The stresses of testing to 45.5 T partially flattened the tape and also moved the bending center of the tapes toward the magnet center, regardless of the slit edge orientation. The data on the as-received tape was averaged from three different pieces.

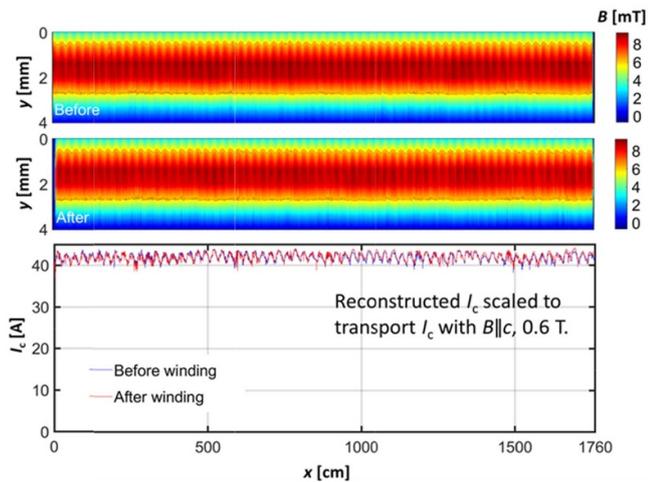
To assess the mechanical damage of the LBC pancakes, we have to evaluate all potential sources of overstress. First, we consider whether the winding procedures damaged the conductor  $J_c$  properties. Indeed, figure 9 compares YateStar scans before and after pancake winding. They show no observable change in  $I_c$  caused by the winding procedures, either locally or globally, even at the fine mm-scale resolution of the Hall probes. This tape was then rewound into P8 of LBC3, where it contributed to the achievement of 45.5 T. We accordingly conclude that damage observed in the deconstruction of the LBC coils was not caused by the coil winding process but by the subsequent test. We do note that the tapes were wound with

**Figure 9.** Comparison of a tape before and after winding into P8. The  $I_c$  values are reconstructed from the magnetization maps and scaled to the transport  $I_c$  for  $B \parallel c$ , 0.6 T at 77 K. There is no observable damage made by winding (and unwinding).

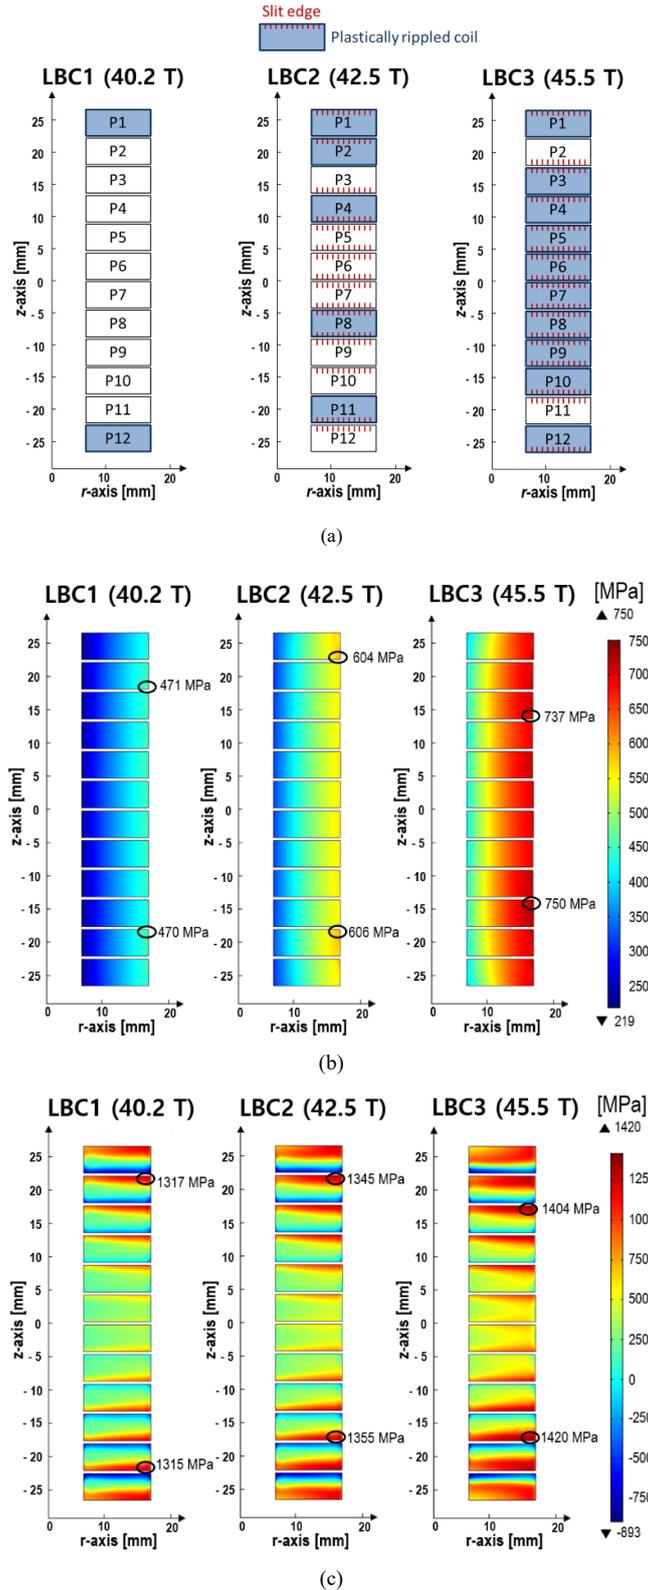
Figure 12(a) summarizes the plastic rippling behavior of all pancakes in the three LBC series; LBC1 reached a quench field of 40.2 T, while LBC2 quenched at 42.5 T and LBC3 achieved 45.5 T. The short red lines in LBC2 and LBC3 mark the slit edges of the pancake coils. It is apparent that more pancake coils experienced plastic rippling as LBC reached a higher field. However, almost all the pancakes with their single slit edge facing inward, i.e. front-slit or back-slit tapes, survived

**Figure 12.** (a) A summary of the observed plastic rippling behavior of all pancake coils of the LBC series showing where mechanical rippling deformation was observed in the *post mortem*. The slit edges are marked by short red lines in LBC2 and LBC3. Slit edge positions were not controlled in LBC1. (b) Calculated hoop stress distribution of LBC1-3 at their peak fields without considering screening currents. (c) Calculated hoop stress of the LBC series at their full fields with transport and screening currents considered: LBC1 that reached 40.2 T; LBC2 at 42.5 T; and LBC3 at 45.5 T. The maximum stresses are circled in each figure.

without damage except P4 in LBC2, which shows a minor  $I_c$  degradation in its outermost turns, as shown by the Yate-Star scans in figure 2. Figure 12(b) shows the *JBR* hoop stress distribution of LBC1-3 at their peak fields without considering screening currents. We used the ‘measured’ dimensions of each pancake coil for the stress calculation. As a result, the peak stress was obtained in those pancake coils away from the magnet center as indicated in figure 12(b), which is barely different from the peak stress in central pancake coils. In any cases, the *JBR* stress values in all LBC series are incapable of generating the plastic rippling seen in figure 1. Figure 12(c) shows our simulations of the magnetic stress of the three LBC series at their peak quench fields. The so-called ‘index’ model with  $n = 21$  was adopted to model the non-linear  $E$ - $J$  characteristics of the REBCO tapes and domain homogenization and the 2D edge element formulation were adopted so as to be able to simulate both transport and screening currents simultaneously [24]. Recently several groups have reported similar simulations of screening current stress for various REBCO coils [23, 25–27]. A common feature is that none is yet numerically perfect. We thus offer our calculation more as a depiction of the very important redistribution of stress which occurs when screening current stresses are taken account of rather than an accurate calculation of the stress. Like the above model calculations, it appears too that our calculation overestimates the stress in the presence of screening currents.

Figure 12(c) includes the screening currents and shows that the peak local stress occurs not in the central windings where *JBR* is maximum but in the end windings with a peak value exceeding 1.4 GPa (P3 and P10, LBC3), which appears to be unreasonable as it far exceeds the yield and perhaps even the ultimate tensile stress of Hastelloy at 4.2 K. In addition, P3 and P10 of LBC1 and LBC2 survived all tests, including the quenches. But on the other hand, the calculations also show that the total current densities (transport + screening) of end pancake outer edges where the transport current preferentially flows are always larger than those at the inner edge where the residual screening current flows. These simulations correspond qualitatively to our *post mortem* observations: (1) the rippling plastic deformation of the REBCO tapes always occurs at the outer edge; (2) the bending center of end pancake tapes always moved toward the magnet centers, no matter how the slit edges were oriented.
