Analysis of local burnout in a sub-scale test coil for the 32 T magnet after spontaneous quenches during fast ramping

To cite this article: X Hu *et al* 2022 *Supercond. Sci. Technol.* **35** 075009

National High Magnetic Field Laboratory, Florida State University, Tallahassee, FL, United States of America

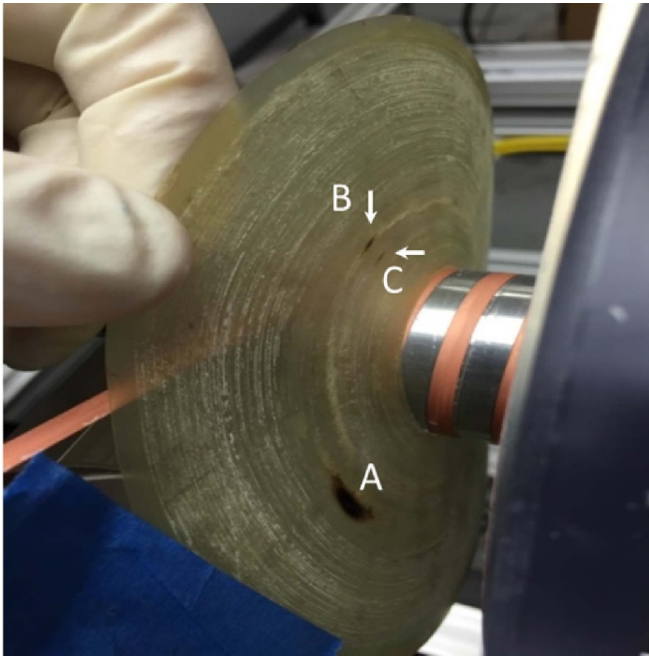
After these quenches, coil 1 was disassembled, and signs of physical degradation were very obvious on the bottom double pancake, as shown in the image of the G10 spacer located in the middle of the double pancake (figure 3). Three burn marks (A, B, and C) can be clearly seen on the spacer, which was also permanently warped. The positions of the burn marks

indicate that SP72 is the tape that initiated the spontaneous quenches.

Figure 3. Picture of the G10 spacer in the middle of the damaged double pancake. The three zones are labeled A, B and C. The latter two are very localized and thus indicated by arrows. The spacer was permanently warped by the quenches.

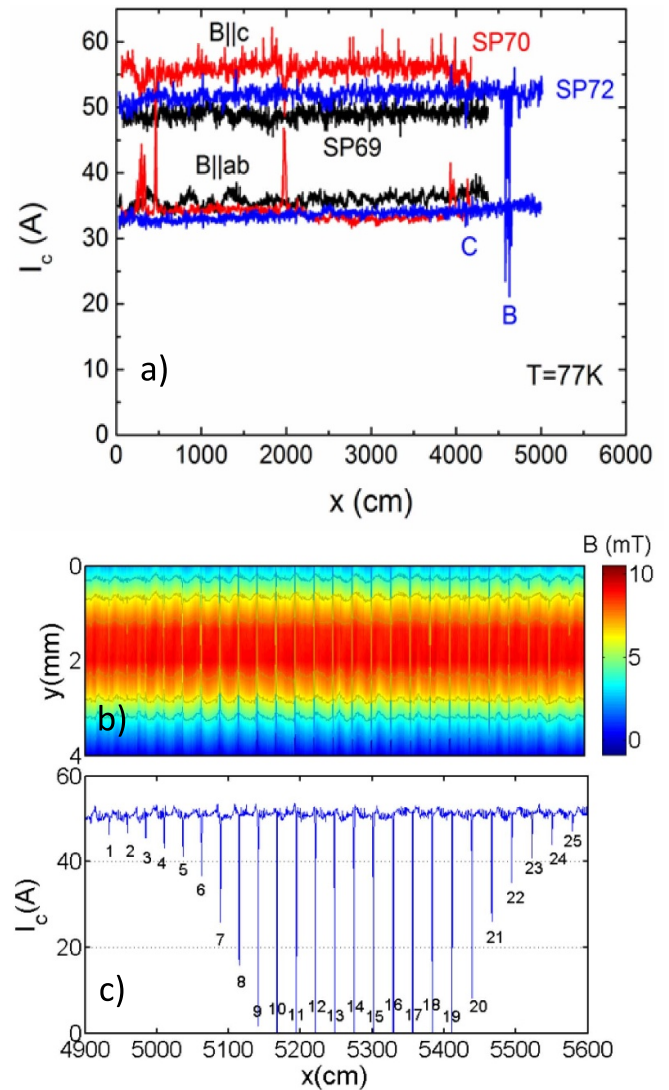
The position dependence of I_c at 77 K and 0.6 T of the three tapes from the damaged module is shown in figure 4(a). All three tapes have a much larger I_c for $B||c$ than for $B||ab$, indicating strong vortex pinning by dense, near optimal BZO nanorods [18], but it can be seen in figure 4(a) that there are significant lengthwise I_c fluctuations that we attribute to lengthwise variations of the vortex pinning center density and effectiveness [16]. The three damage zones A–C caused by the spontaneous quenches are all located in tape SP72, A being the most serious. YateStar transport measurements were not carried out for zone A in order to avoid further damage but the 2D magnetization map in figure 4(b) of zone A clearly show the impact of the burn damage on 25 neighboring turns. The map is obtained by measuring the remnant field of the tape with a seven-element Hall probe array [11, 25]. The inability to trap the field means losses of superconductivity. These Hall maps were then used to reconstruct the transport $I_c(x)$ at 77 K, 0.6 T shown in figure 4(c). Unlike the only partially damaged zones B and C, I_c of many turns in damage zone A drops to zero.

Figure 4. (a) Transport $I_c(x)$ measurement of the three tapes of the degraded double pancake ($T = 77$ K, $B = 0.6$ T). The damage zones were all found in SP72. Damaged zones B and C on SP72 are shown at left but no transport evaluation could be performed on the length containing zone A. (b) Two dimensional (2D) Hall magnetization map of 25 turns around damage zone A. (c) The reconstructed $I_c(x)$ according to (b) scaled to the measured transport data of undamaged regions with $B||c$, 0.6 T. The numbered damaged zones are all localized to regions located on a radial line through the central quench damage origin and are numbered from inner to outer. Turn 1 is the innermost turn with detectable degradation.

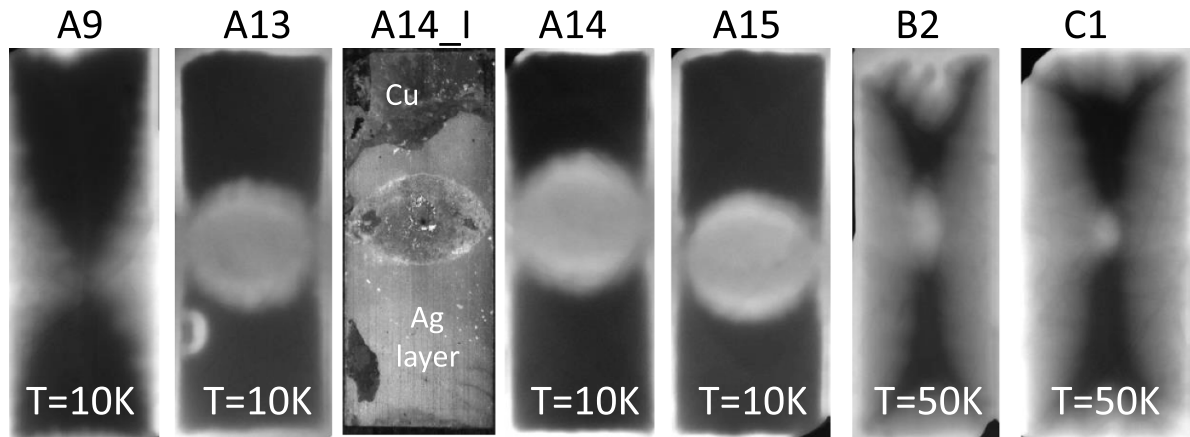
After the damaged sections were located, 10 mm long samples were cut out for the MO images shown in figure 5. The bright areas in the images represent damaged, non-superconducting regions incapable of generating screening currents that can inhibit flux entry. By comparing their sizes, we determined that turn 14 contains the center of zone A and

is very likely the place where the first of the three spontaneous quenches initiated. The damaged quench areas have almost perfectly circular shapes. However for samples away from the center, degradations start from both edges (e.g. sample A9). The small defect on the lower left edge of sample A13 is interesting but we are uncertain whether it was pre-existing and not related to the spontaneous quenches or perhaps a defect induced by the large thermal strains of the quench. For the less damaged zones B and C where I_c never dropped to zero, the damage was more localized and was better revealed by higher temperature MOI where J_c is lower and flux penetration easier.

Figure 5. Magneto-optical (MO) images of samples ($10\text{ mm} \times 4\text{ mm}$) cut out from the damage zones in turns 9, 13, 14 and 15 of zone A, turns 2 and 1 of zones B and C. A14_I is the surface optical image. Damage in zone A was imaged at 10 K and at 50 K for less heavily damaged samples from zones B and C. All images were made after zero field cooling (ZFC) and then applying fields of 120 mT for sample A9, B2 and C1, and 20 mT for A13–15. The bright regions indicate substantially complete flux penetration due to these regions not being superconducting. The dark regions are superconducting. The small defect at lower left on sample A13 might be pre-existing and not related to the quenches.

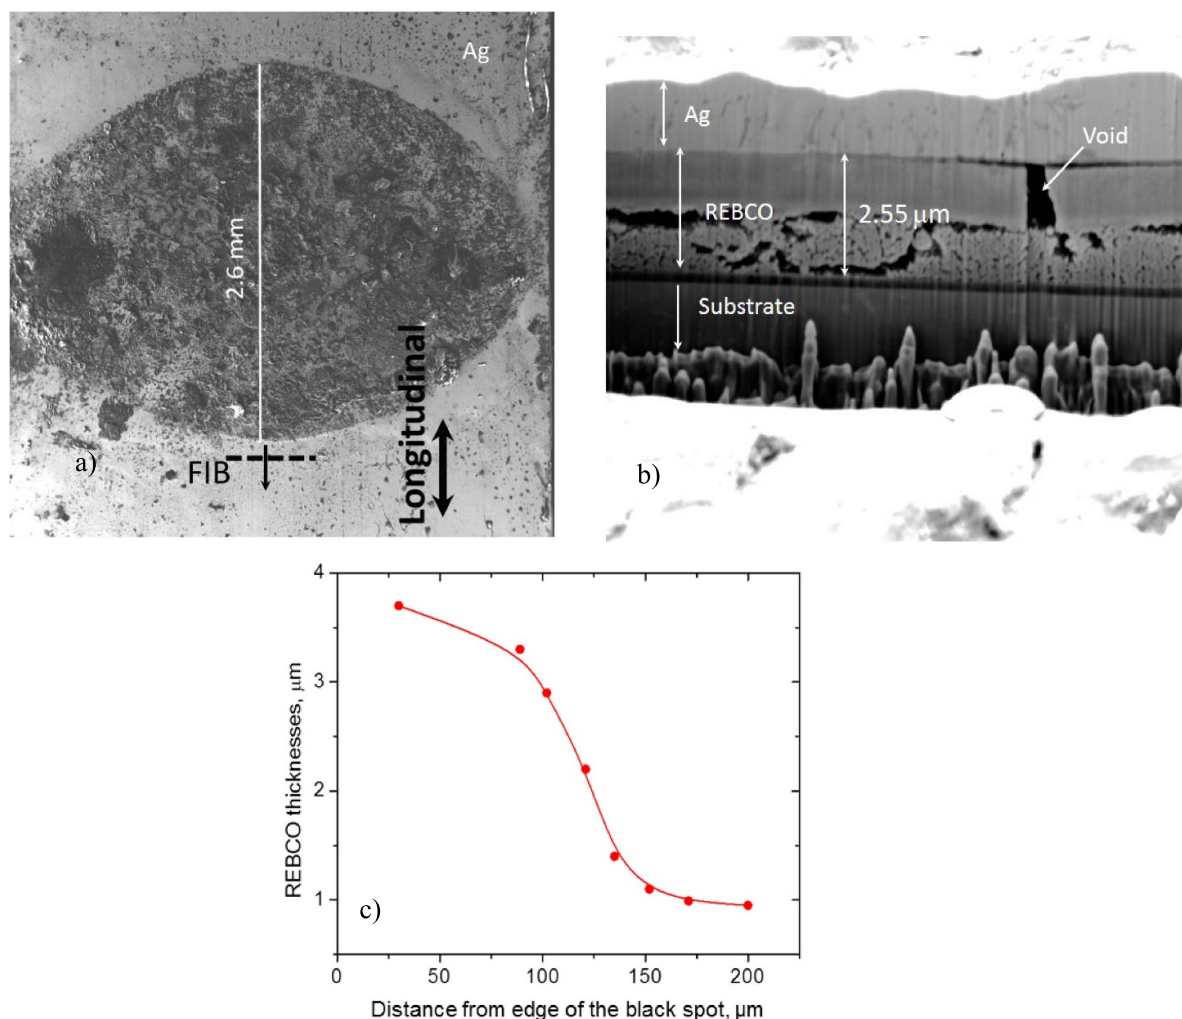
To better examine the most damaged sample A14, the Cu layer was etched away and examined by SEM. Figure 6(a) shows that there is an elliptically-shaped dark region with a sharp interface to the neighboring Ag, rather than the circular shape of the MO images (figure 5). The black spot is about 2.6 mm along the conductor axis and about 3.5 mm transverse, both dimensions being smaller than those observed MO in figure 5. As we discuss later, we believe that the sharp interface marks the boundary between smooth Ag that remained solid and the rougher, blackened area where the Ag melted and mixed with the Cu overlayer to make a low melting (at least $779\text{ }^\circ\text{C}$ is required) eutectic alloy. Outside the black spot, as in figure 6(b), we believe that the temperature was lower but there was still damage to the REBCO, as indicated by the larger MO damage zones illustrated in figure 5. The SEM image shows that the Ag surface is bumpy at the edge of the black spot, especially for the parts close to the tape edges. Inside the dark spot many craters can be seen without either Ag or REBCO.

Figure 6(b) shows a transverse cross-sectional view (focused ion beam (FIB)) of the region just to the left edge of the blackened Ag spot made along the line indicated by the dashed line marked in figure 6(a). Here the Ag-REBCO interface remains sharp but the REBCO layer itself has separated into two layers, the top without obvious damage but the bottom blown apart by the heat of the quench and with much porosity. Figure 6(c) shows that the REBCO thickness, though highly expanded in the quench zone, falls back to its unperturbed value $150\text{--}200\text{ }\mu\text{m}$ away from the burn zone boundary.

Figure 6. (a) SEM top view of the elliptical black spot observed after etching away the Cu layer. The spot is 2.6 mm wide along the tape axis and about 3.3 mm wide across the tape. (b) SEM transverse cross-sectional view of a FIB section indicated by the dashed line in image (a). (c) REBCO thickness vs distance from the edge of the black spot on the Ag. The measured locations are along the solid black arrow crossing the dashed line where the FIB cross-section was made.

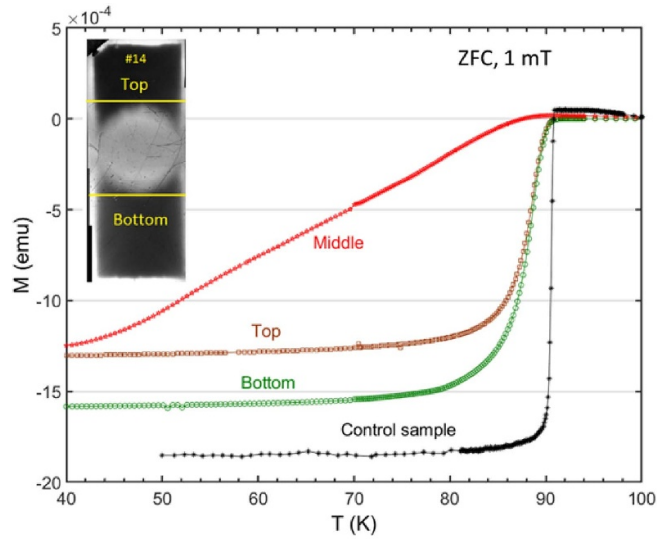
The extreme localization of damage in the burn zone is also reflected in SQUID magnetization T_c traces. Figure 7 compares warming T_c transitions in 1 mT after ZFC to 40 K of the burn zone of sample A14, its immediate neighbors and a control sample far away from it. The middle burn-zone piece is about $4\text{ mm} \times 4\text{ mm}$ and thus contains regions outside the burn

zone that do prevent flux penetration. Indeed all four samples show superconducting transitions. Although T_c of the heavily damaged middle piece is about 3 K lower than others, it is progressive over a range of about 50 K, suggesting maintenance of the REBCO structure with some expulsion of O and loss of T_c due to warming by the burn zone. By contrast the neighboring top and bottom pieces have very similar transitions to that of the control sample. These T_c transitions also speak to the intense localization of the damage in the burn zone and the negligible longitudinal quench propagation velocity.

Figure 7. Temperature dependence of magnetization after ZFC to 40 K, then applying $H = 1$ mT during warming for the three pieces of sample A14 (Cu has been etched away) and a control sample taken far away from the damage zone.

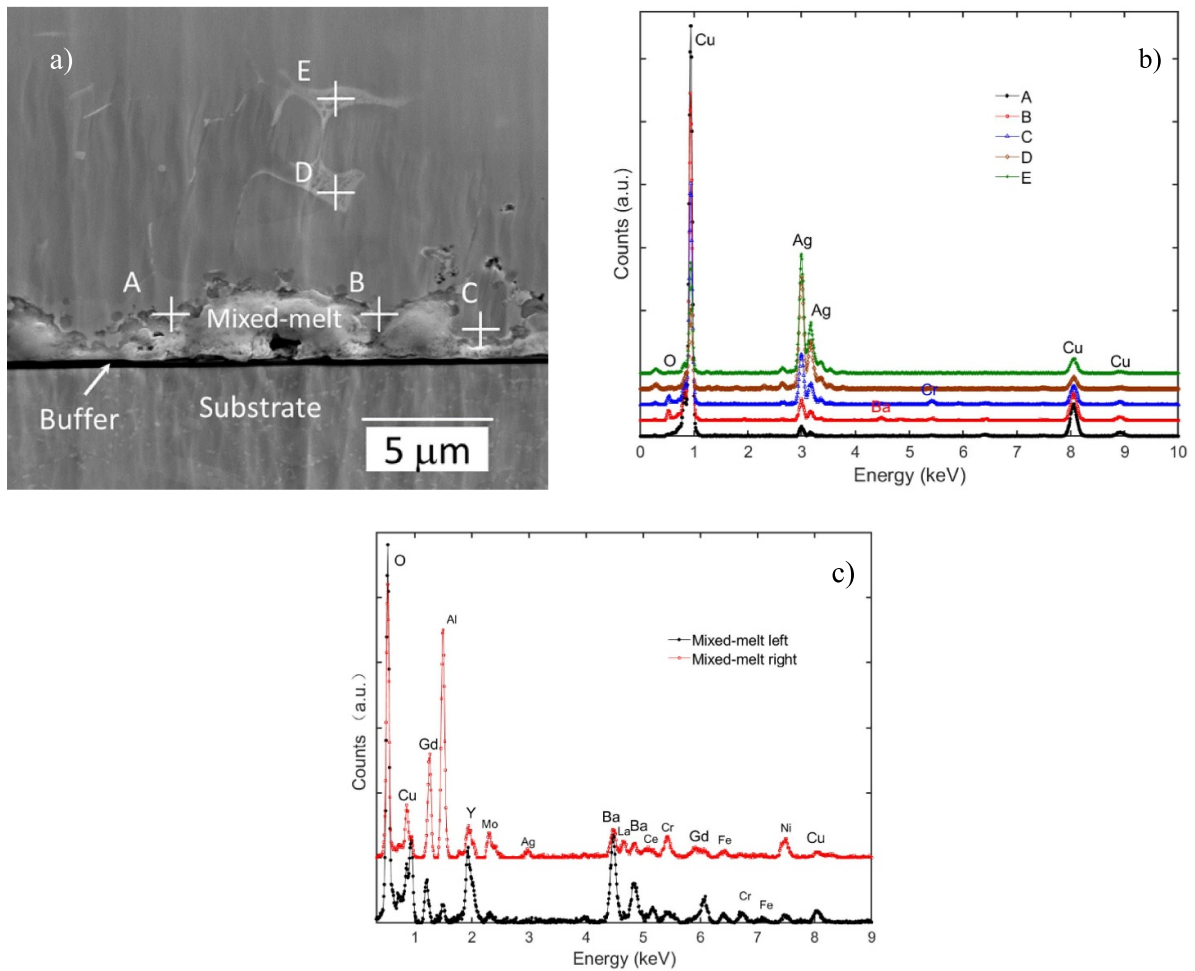
temperature reached at least 779 °C, the melting temperature of the eutectic composition of Cu71.9%Ag. That the highest Ag content is a little lower suggests that even higher temperatures were reached, as also does the highly porous structure of the REBCO layer in the burn zone and the off-stoichiometric EDS data in figure 8(c).

Figure 8. (a) Ion-beam polished SEM cross-section of sample A15. A–E are positions where EDS analyses were performed. (b) EDS spectra of A–E. (c) EDS of the mixed-melt lump marked in (a), on which two spots were examined. Besides Cu and Ag, there are also other elements either from the buffer layer or the Hastelloy substrate. The REBCO spectra vary but clearly all deviate from that of stoichiometric RE123.

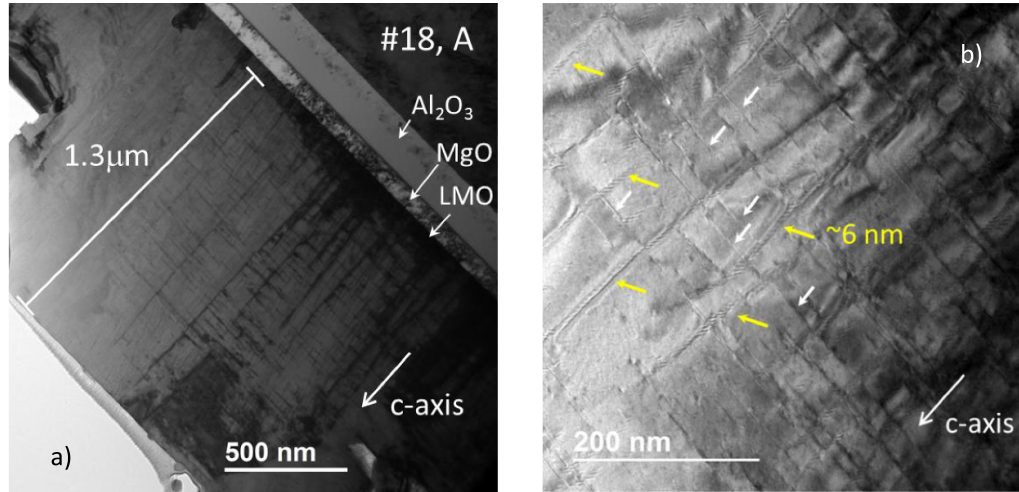
Because we now know that the 4 K high field properties of the tapes are closely tied to the perfection of the BZO nanostructures [19], we then compared the nanostructure by TEM of samples immediately located next to the burn zone with samples cut close to but apart from the burn zone under the assumption that the cause of the local burn out might have been variations in the BaZrO₃ and RE₂O₃ nanostructure. Accordingly we cut out a sample from turn A18 from a region about 1 mm away from the edge of the damage zone (recall that this is not a primary damaged zone but one secondarily damaged by the intense heating in turn 14). Figure 9 shows that the BZO nanorod diameters are closely clustered in the range of 5.5–7.5 nm, mostly around 6 nm, which is the expected

optimum range for highest J_c in these tapes [18, 19]. No BZO nanoparticles or large precipitates were observed. Thus the nanostructure at this point appears to be what manufacturing desired. The planar defects indicated by the white arrows are the consequences of the quench heat and have caused 30% increase of the thickness of REBCO.

Figure 9. TEM cross-sectional view of a region on turn A18. (a) A large-area, low-magnification view. The buffer layers, Al_2O_3 , MgO and LaMnO_3 (LMO) are indicated by arrows. (b) A higher-magnification view. BZO nanorods indicated by yellow arrows have diameters of about 6 nm. The planar defects indicated by white arrows are about 1 to 2 nm thick.

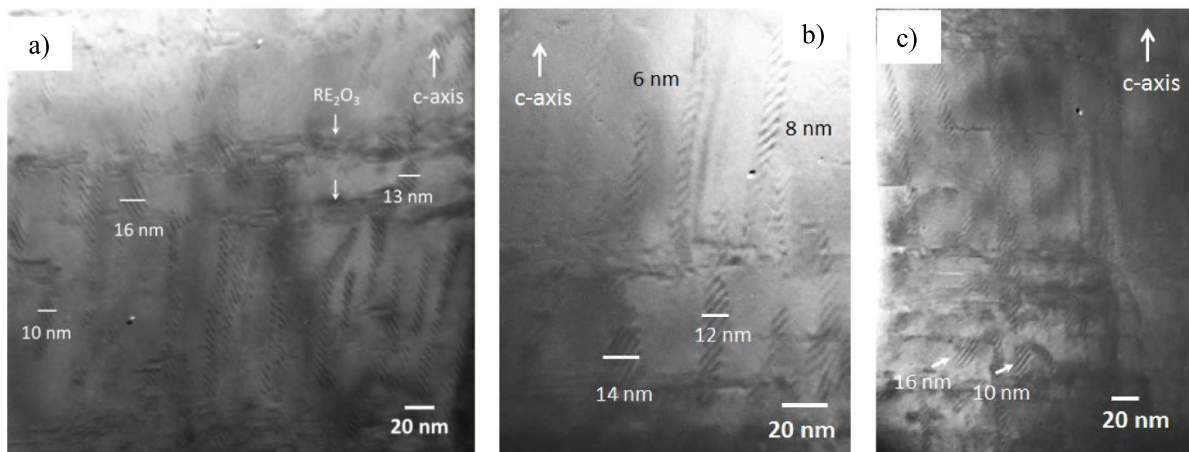
By contrast study of the regions where the spontaneous quenches initiated showed a different story. Samples were cut 3 to 4 mm away from the black spot edges of the centers of turn A14, B2 and C1. Figure 10 shows the cross-sectional view of these samples. In the zone A sample very close to the burn-initiation zone, many BZO nanorods have a large diameter of order 10–16 nm and are only 40–50 nm long. RE₂O₃ precipitates as indicated by the arrows lying in the *ab*-plane are also obvious, which usually favors the vortex pinning in the *ab*-direction at lifted temperature [17]. As discussed later, we expect this nanostructure to be far from optimum and to set up local low J_c conditions. In the less critically damaged zone B, the average length of BZO nanorods is a little longer than that

Figure 10. (a), (b) and (c) TEM cross-sectional view of samples from turn A14, B2 and C1, respectively. Samples were cut 3 to 4 mm away azimuthally from the burned zone centers. The BZO morphology is very different from the control, undisturbed area imaged in figure 9. Many much larger and shorter BZO nanorods and nanoparticles with diameter over 10 nm are present.

in zone A, but thick BZO nanorods with diameter larger than 10 nm are present as in zone A. The BZO nanorod diameter is most uniform in the zone C sample. Thus there is a clear difference between the BZO morphology of primary damaged zones A, B and C and neighboring undamaged zones. A recent study of the wide variety of properties observed in the more than 100 lengths of REBCO used for the 32 T magnet shows that fluctuations in the density, spacing and morphology of the BZO play an enormous role in determining the magnitude and field dependence of J_c [19], thus implicating the local fluctuations of nanostructure in the damage observed in our study.

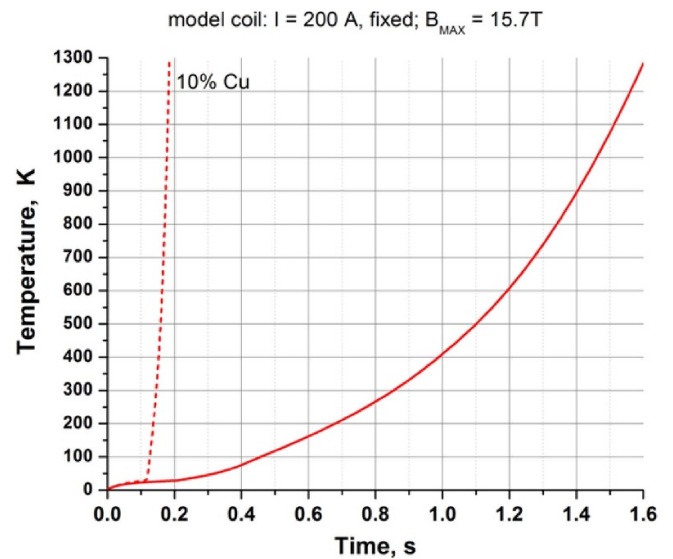
Figure 11. Simulation of a localized unprotected quench initiated in the region with a $1 \text{ mm} \times 4 \text{ mm}$ transverse defect. The temperature dependent anisotropic thermal diffusivity was included appropriately. The solid line is the case with $100 \mu\text{m}$ thick Cu (nominal) in the REBCO tape, and the dashed line is with $10 \mu\text{m}$ thick Cu (artificially reduced in calculation to assess the effect of the amount of copper on the rate of temperature rise).

the simulation as is detailed in [26–28]. Figure 11 shows the time dependence of temperature at the defect. It demonstrates that the Cu–Ag eutectic temperature of 779 °C can be reached very rapidly, in fact within 1.5 s. But, because of the intense localization of the defect, both in the model and in reality, the peak voltage remains below 0.5 mV, which makes its detection very difficult. In fact the quench only triggered the protection system after it was too late to prevent the localized burning.
