Metallographic analysis of 11 T dipole coils for High Luminosity-Large Hadron Collider (HL-LHC)

To cite this article: Shreyas Balachandran *et al* 2021 *Supercond. Sci. Technol.* **34** 025001

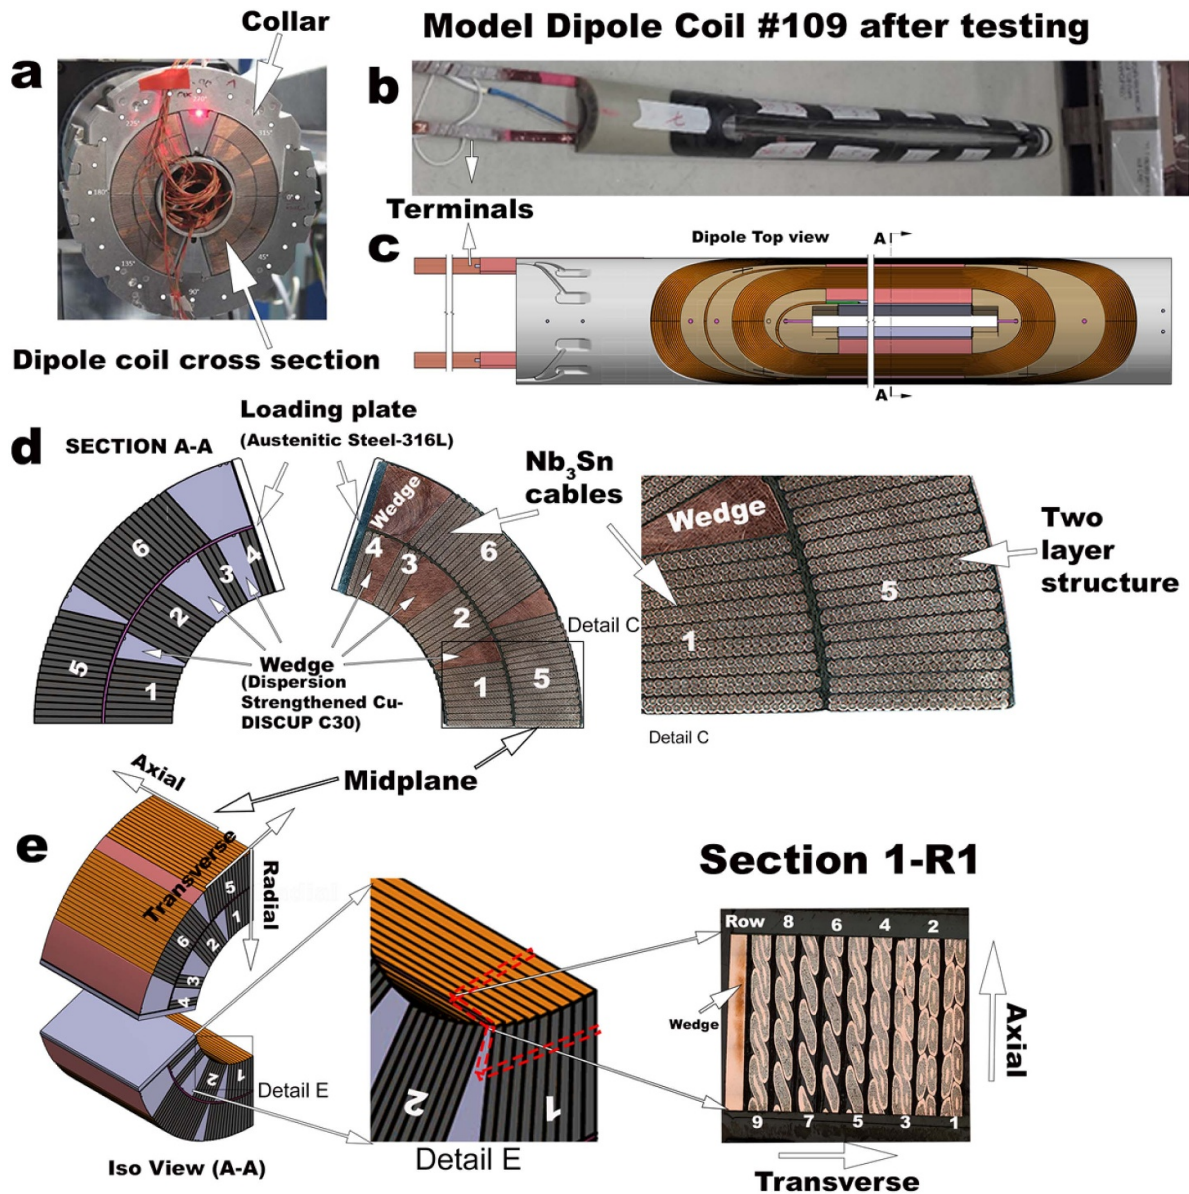
Figure 1. Segments of the 11 T dipole coil at various stages of disassembly, (a) cross section of collared 11 T dipole coil assembly made of two coils, (b) 11 T dipole short model coil #109, (c) top view of a 11 T dipole coil, (d) cross-sectional view of section AA, including the cut dipole segment of Coil #109 used in this study, (e) isometric view of the dipole section to visualize the coil segments analyzed by metallography.

After collaring coil #109 was assembled in 11 T twin aperture dipole MBHDP102, as shown in figure 1(a). Cold tests of MBHDP102 revealed a substantial critical current limitation at the mid-plane turns of coil #109, and the n -value was also strongly suppressed [10, 12], both indications of possible Nb_3Sn filament breakage. The critical current limitation probably caused the relatively low quench currents of magnet MBHDP102.

The critical current deterioration, which was detected over an extended length in the straight part of the coil, was presumed due to excessive mechanical stresses applied during the collaring of the coil [10]. Section AA in figure 1(c) is a coil cross-section in which filament damage is expected. Coil #109 was de-collared and central section cuts were made for metallographic examination. A central section is shown in figure 1(d) was diamond wire saw cut and analyzed further.

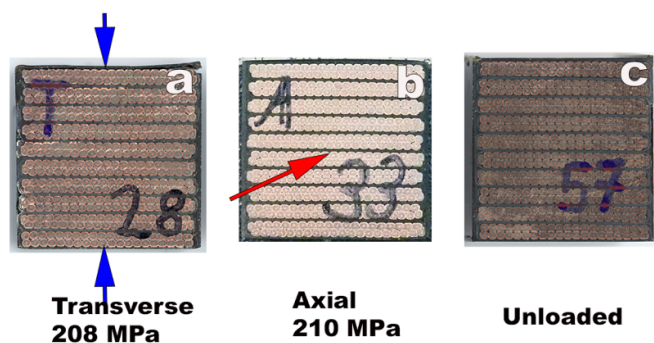
Figure 2. Ten-stack Nb_3Sn coils in three different states: (a) #28-compression loaded to 210 MPa (change to 210 MPa in the figure) along the direction transverse to the Nb_3Sn wire cross-section, (b) #33-compression loaded to 210 MPa along the axis of the superconductor wire, and c) is an unloaded ten-stack.

Ten-stack samples No 28 and No 33 (figure 2) were uniaxially loaded to compressive peak stress of 210 MPa. Ten-stack #28 was loaded in the transverse direction (corresponds to figure 1(e)), and No. 33 was loaded in the axial direction. Unloaded sample #57 was used as a reference in this study.

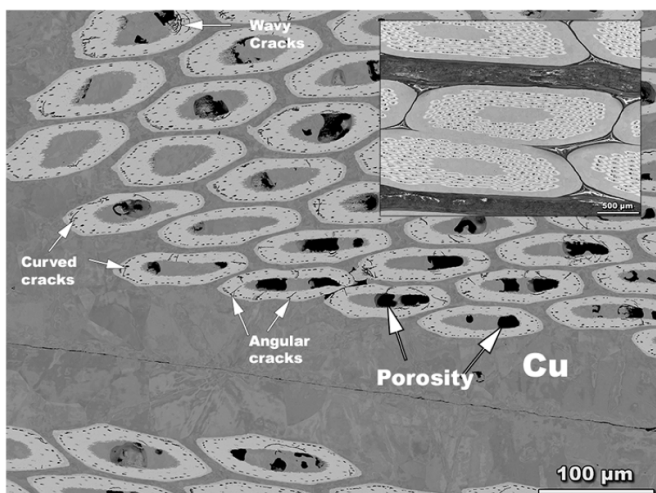
Figure 3. FESEM-BSE image of polished and etched high stress region in model coil #109 at the interface between two strands shows cracks in the Nb₃Sn filaments. The crack morphologies vary depending on location in this section with possibility of—angular oriented cracks, curved cracks and wavy cracks. The adjacent Cu also reveals diffraction contours related to strain in the BSE image.

Section 1-R1 of Coil #109 was mounted, polished, etched, and imaged. Cracks were observed in this section with varying densities based on location. Crack morphologies vary in the filament, as shown in figure 3. The commonly found cracks are

The results that we report here indicate that the 11 T dipole coils have been subjected to a multi-axial stress state. This is indicated by the Nb₃Sn crack distribution and the varying crack orientations shown in figure 3. Observed cracks are curved and angular meaning complex loading conditions that lead to differences in principal stress directions. Cracks are oriented along principal planes and in principal directions in the ten-stack sample A28, which is transversely loaded to 210 MPa. The transverse compressive stress limit of the 11 T dipole Rutherford cable has been determined by critical current measurements after transverse compressive loading the cable at RT. It was observed that when the transverse compressive stress exceeds about 150 MPa a significant critical current degradation occurs [22]. Lorentz force simulations of the 11 T dipole indicate that the main region for high stress is around 145 MPa ([13], figure 5.25, pg. 59) in section 1-R1,

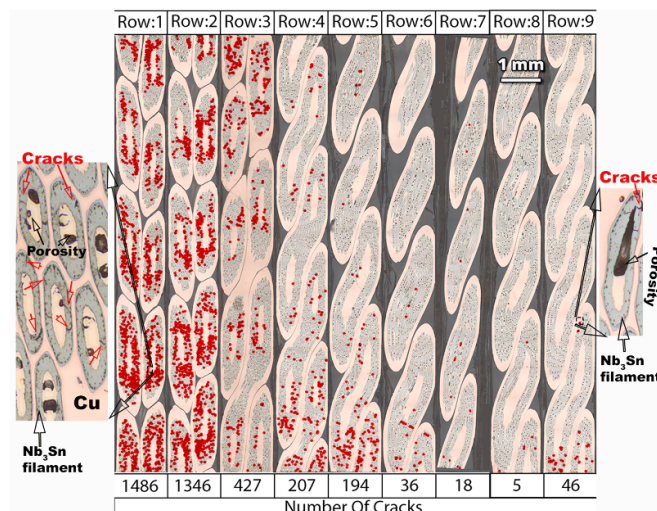
Figure 4. Light micrographs of section 1-R1 showing local variations in the number of cracks within the section. Some of the cracks are correlated to porosity. The crack orientations also vary between angular and curved cracks possibly indicating the state of stress in the Nb₃Sn filaments.

however, figure 4 indicates that there is extensive damage in regions in #109 away from the high stresses caused by the Lorentz forces. The absence of cracks in the same high-stress region in coil GE-C02, which consists of a similar design and volume fraction of epoxy and cable indicates that the stress during the training or magnet operation does not cause this damage. The degradation of coil GE-C02 that was detected in the coil end after the thermal cycle of the magnet is presumably caused by stresses due to thermal expansion mismatch. The samples analyzed in the straight section did not fail, there was no I_c degradation, and as expected, we do not observe cracks in the Nb₃Sn filaments.

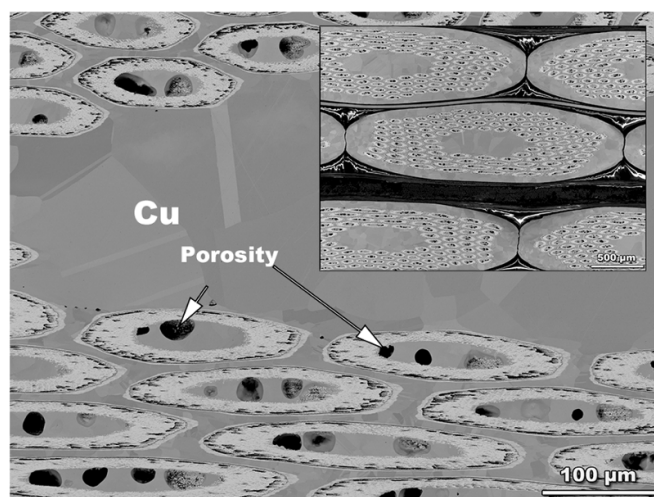
Figure 5. FESEM-BSE image of a polished and etched high stress region in model coil GE-C02 shows no evidence of cracks in the Nb₃Sn filaments. Annealing twins are observed in the Cu matrix.

Here was no I_c degradation in coil GE-C02 after training. There were no cracks detected in this analyzed coil. A representative BSE image of Row 1 is shown in figure 5, and it can be seen that the Cu matrix in the core of the strand contains annealing twins, typical of recrystallized Cu. Nevertheless, deformation contrast is observed in Cu along the edges of the superconductor wire.

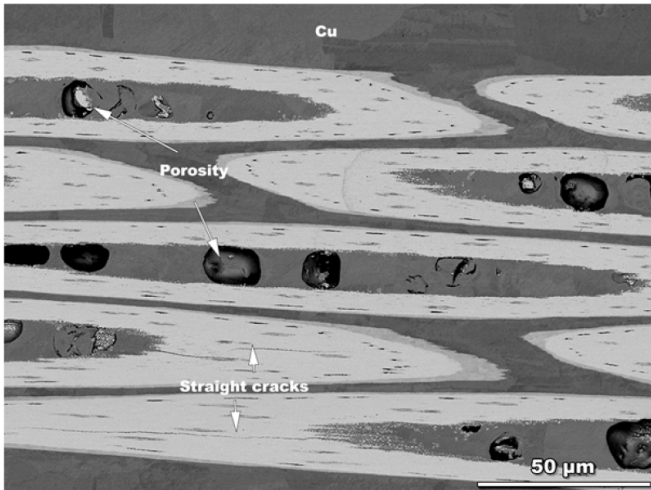
Figure 6. Cross-sectional FESEM-BSE image of transverse compression sample #28 which underwent a stress of 210 MPa, reveals straight cracks that run through the Nb₃Sn sub-elements. The plane being imaged here is the Transverse- Axial plane.

Ten-stack samples were uniaxially compressed in transverse versus axial directions to a similar stress value of ~210 MPa. Figure 6 shows that sample #28, which was loaded in the transverse direction, has Nb₃Sn cracks along the sub-element filament major axis. The Cu stabilizer shows signs of deformation contrast, as indicated by the BSE image. In contrast, the axially compressed ten-stack sample #33 does not show any cracks in the Nb₃Sn. Figure 7 shows a typical wire cross-section, with regions around the wire edges where deformation contrast in Cu is observed even in the axially compressed samples.

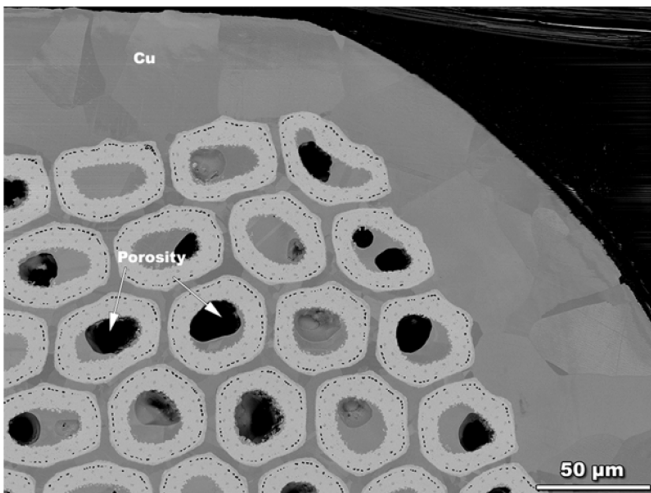
Figure 7. Cross-sectional BSE image of axial compression sample #33, indicates no cracks the Nb₃Sn sub-elements. The plane imaged here is the Radial- Transverse plane.

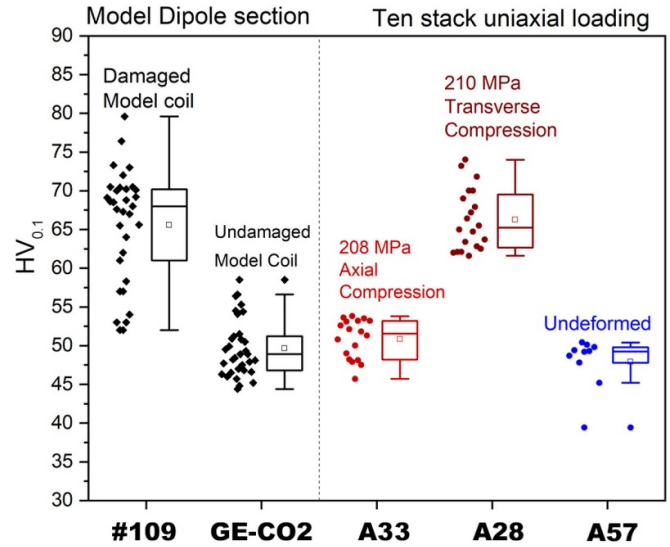
Figure 8. Vickers hardness variation in the Cu stabilizer for the different samples in this study. The dipole segment hardness for model coil #109 varies between a low of 55 to a high of 80.

As indicated in figure 8, there is a wide distribution in the hardness in the damaged sections, for instance- #109 hardness values vary between HV_{0.1} 55 and 80, and A28 is between HV_{0.1} 62 and 75. Comparatively, the GE-C02 section has a lower and much tighter distribution in hardness values, between HV_{0.1} 45 and 60. A possible explanation for this variation could be the high non-linear work hardening of Cu at low strain values. Small strain variations could lead to differences in the work-hardening, and hardness of Cu. A full map of the hardness of Cu versus dipole cross-section would provide data that could lead to a comprehensive experimental verification of the load sharing between different elements of the dipole magnet and is in progress.

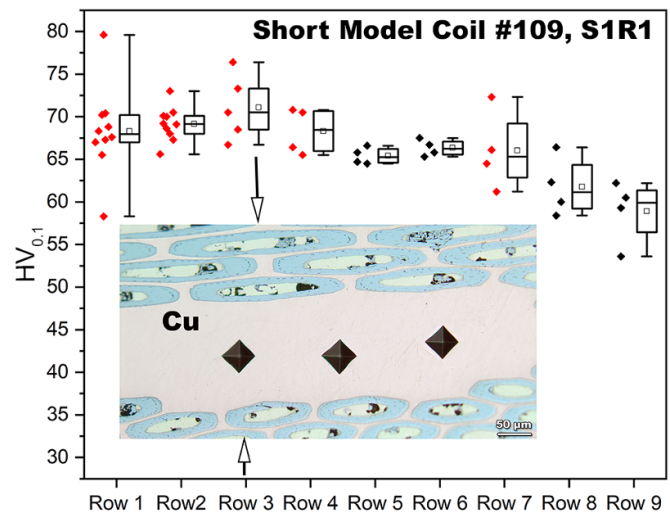
Figure 9. Vickers hardness distribution in the Cu along the different rows of coil #109 section S1R1. Hardness measurements made in the Cu adjacent to filaments with cracks are marked in red.

are over HV_{0.1}, that are distributed along the rows in #109. There is a general trend of decreasing hardness from Row 1 through to Row 9. For a similar section in Coil GE-C02, figure 10 indicates a general lower overall hardness compared to coil #109. The lowest hardness in Cu occurred in Row 3, and Row 8 and corresponded to values as low as HV_{0.1} ~ 35. The highest hardness was around HV_{0.1} 62 and occurred in Row 8 of the section.

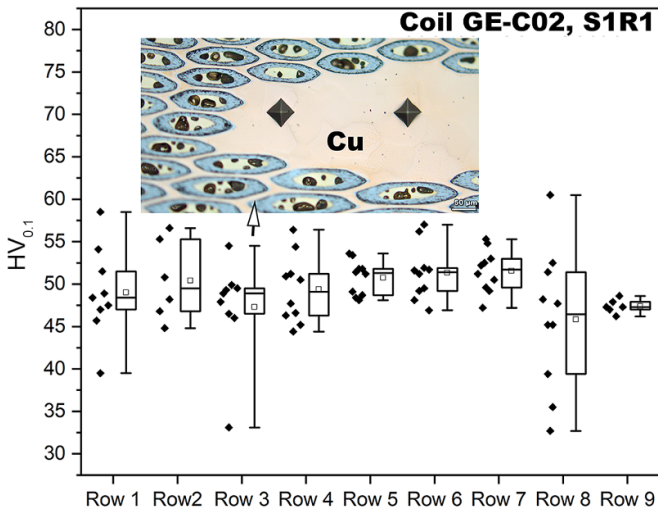
Figure 10. Vickers hardness along the different rows of the 11 T series dipole coil GE-C02 cross section.
