## Analyses of the plastic deformation of coated conductors deconstructed from ultra-high field test coils

To cite this article: Xinbo Hu *et al* 2020 *Supercond. Sci. Technol.* **33** 095012

# Analyses of the plastic deformation of coated conductors deconstructed from ultra-high field test coils

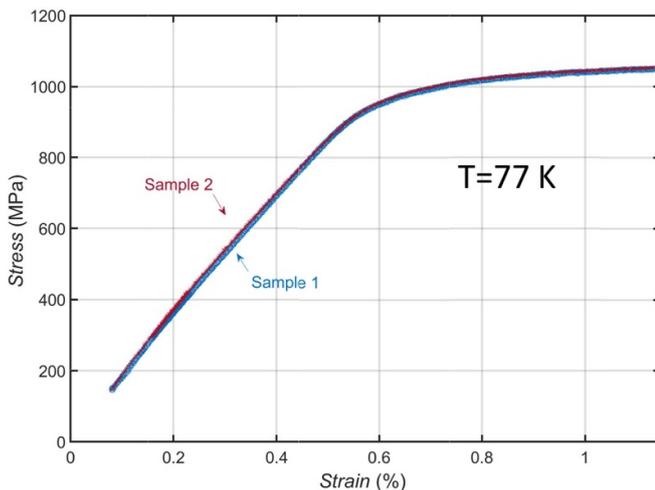
Figure 1 shows that one obvious result of our *post mortem* investigation is that some pancakes were significantly and inhomogeneously plastically deformed by energization or by the subsequent quench. Figure 10 shows the 77 K stress–strain curves of two samples of the as-received tapes made with an attached extensometer, both giving identical results within the experimental points. The first yield event occurs at  $\sim 400$  MPa, presumably where the  $\sim 10$   $\mu\text{m}$  of Cu and 4  $\mu\text{m}$  of Ag yields. A definable yield stress of the whole tape occurs at  $\sim 900$  MPa and the 0.2% yield strength occurs at  $\sim 1.02$  GPa. The linearized elastic modulus below 400 MPa is 192 GPa, declining to  $\sim 170$  GPa above the plastic yield regime of Cu and Ag. Based on measurements of other SuperPower tapes we expect the 4 K properties to be 5%–10% higher. By contrast the maximum calculated transport current hoop stress  $JBR$  was 750 MPa which occurs in P10 of LBC3, values which are clearly not high enough to plastically deform the Hastelloy, leading us to conclude that there must be additional stresses to cause the observed plastic deformation damage.

**Figure 10.** Stress–strain curve of as-received tapes at 77 K. The maximum  $JBR$  hoop stress of any pancake was 750 MPa in central pancakes P10 in LBC3.

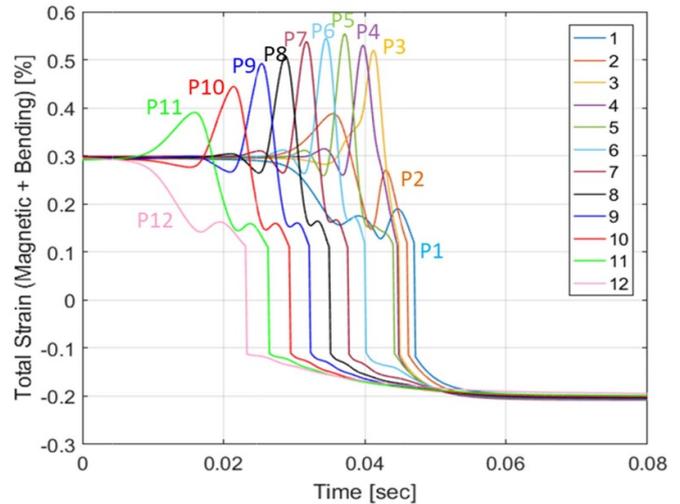
**4.3.2. Induced overcurrent.** A second important factor is the ‘induced overcurrent’ that is often observed in a no-insulation HTS coil during rapid quench. Using our lumped circuit code (which does not take account of screening currents), we simulated the quench propagation within LBC3 [17], the simulated voltages of each pancake agreed reasonably well with the measured voltages on each pancake. Indeed we found that these induced overcurrents corresponding to these voltages did generate a significantly higher calculated peak stress of  $\sim 900 \text{ MPa}$ , a value now rather close to the tensile yield stress of figure 10, at least for the middle pancakes where the largest stresses are predicted. As figure 11 shows, P12 initiated the quench, the other pancakes then quenching sequentially from bottom to top. We conclude that these overcurrent stresses are certainly important but we return to the fact that the most characteristic plastic damage to the LBC coils occurs in the end pancakes where the *JBR* stresses are lower. Figure 11 also takes account of the compressive winding strain on the conductor which reduces the overcurrent strains in the end pancakes 1,2, 11 and 12 to  $<0.4\%$ . Such a strain is essentially elastic according to figure 10, which means that the plastic rippling cannot be fully explained by taking account only of transport and overcurrent stresses.

**Figure 11.** The magnetic plus compressive bending strain versus time during quench for LBC3. The total strain includes the magnetic hoop strain and the compressive bending strain.
