Analysis of local burnout in a sub-scale test coil for the 32 T magnet after spontaneous quenches during fast ramping

To cite this article: X Hu *et al* 2022 *Supercond. Sci. Technol.* **35** 075009

National High Magnetic Field Laboratory, Florida State University, Tallahassee, FL, United States of America

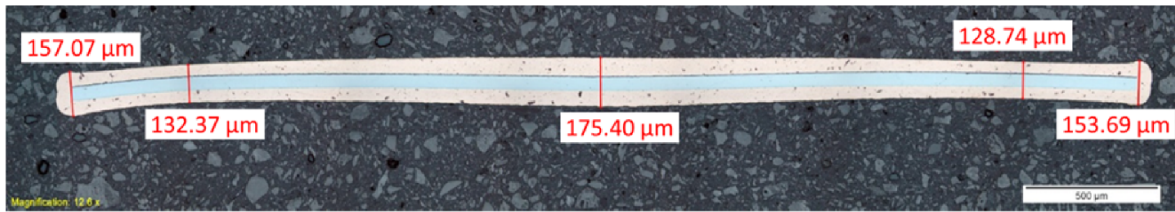
Figure 1. Cross-sectional view of one of the tapes used in the 32 T magnet made to the same specification as the presently studied tape SP72. The thickness across the width is not uniform.

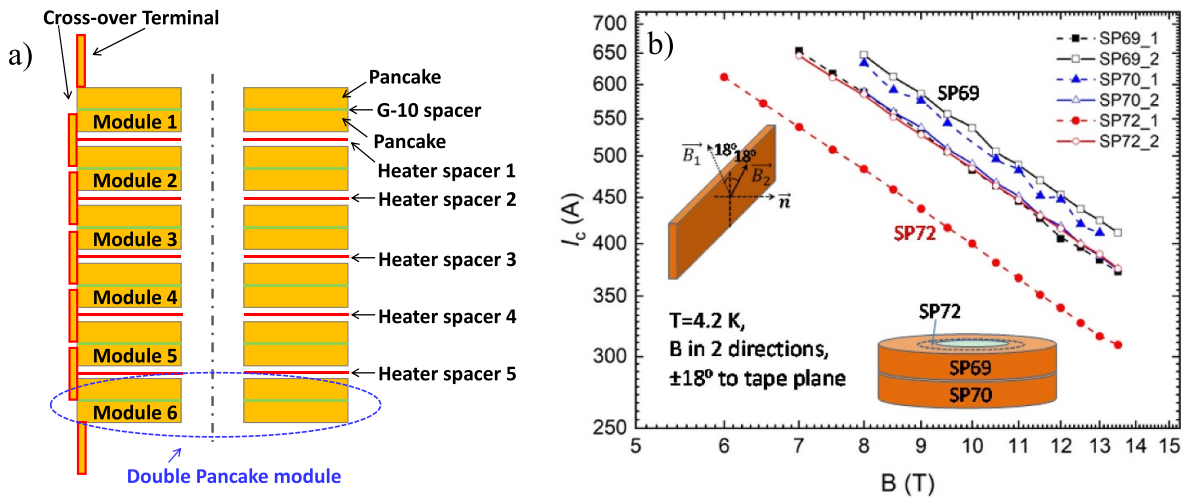
The quench degradation was found on the inner coil 1, which consists of six double pancakes with a field constant of 36 mT A⁻¹. The bottom double pancake was deliberately wound with lower I_c tapes SP69, SP70 and SP72 (internal NHMFL designation) of about equal length, which did however still meet the 32 T conductor specification. It should be noted here that all three tapes were manufactured much earlier than those used in the final 32 T magnet at a time when properties were quite variable and generally lower. SP72, where damage occurred, is the middle tape that transitions from the top to the bottom pancake (figure 2). There are two solder joints inside the double pancake linking the three tape lengths with low resistances of less than 25 nΩ [23]. Figure 2(a) shows the prototype coil schematic, while figure 2(b) shows I_c versus field tilt in ±18° to the tape plane at 4.2 K for the three module six tapes (SP69, 70 and 72) using short samples cut from each tape end before they were wound into the coil. This was a standard measurement for the 32 T project because the field angle at the end pancakes of coil 2 is about 18°. This uncertainty to the *ab*-plane of REBCO occurs because the *ab* plane is offset from the tape plane by certain degrees and the tape plane itself is not perfectly flat. As a result, the critical currents with field tilt in ±18° are asymmetric. We generally use *B*||*ab* representing parallel field to the tape plane, and the designation of ‘+’ or ‘-’ 18° is arbitrary, depending on the positions of the tapes during measurements. Nonetheless, a key point here is that SP72 did have the lowest I_c and largest asymmetry. The angle between the *ab*-plane of REBCO and the tape plane is possibly the largest among the three. Therefore, the coil I_c was limited by tape SP72.

Figure 2. (a) Schematic of the prototype coil 1 [22]. (b) Transport I_c versus field tilt in $\pm 18^\circ$ to the tape plane at 4.2 K for the three module six tapes (SP69, 70 and 72) using short samples cut from each tape end before they were wound into the coil.
