# Property Variations in Modern REBCO Coated Conductors from Multiple Manufacturers

G Bradford<sup>1,2,3</sup>, J Jaroszynski<sup>2</sup>, G Murphy<sup>1,2,3</sup>, A Polyanskii<sup>1,2,3</sup>, J Lee<sup>1,2,3</sup>, D C Larbalestier<sup>1,2,3</sup>

**Abstract.** The complex, multilayer structure of REBCO Coated Conductor (CC) poses significant challenges in the fabrication of high magnetic field devices where large stresses may initiate various forms of damage. Our goal is to peer below the cartoon representations of CC so that, amongst other things, we might better understand whether a CC from one manufacturer is interchangeable with that from another. This involves knowledge of a broad range of electromagnetic, geometric, microstructural, and  $J_c(\theta, B, T)$  properties, and their variations that collectively pose challenges for the fault tolerance of REBCO CC devices. Accordingly, comparative measurements of  $J_c$ , visualization of flux penetration with Magneto-Optical Imaging (MOI), tape geometry from Scanning Electron Microscopy (SEM) of polished cross-sections, and extensive optical microscopy was performed on recently purchased samples from multiple manufacturers.

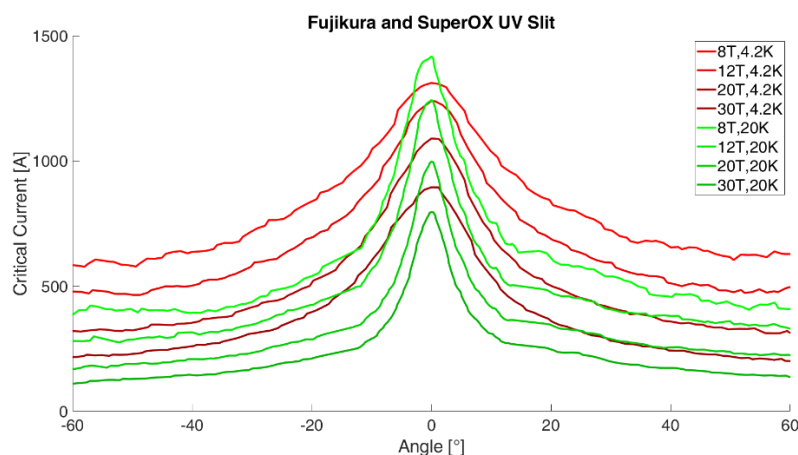
**Figure 5.** Calculated critical current ( $I_c$ ) for two samples characterized in the torque magnetometer in the 31 T resistive magnet at NHMFL in roughly 4 hours. The Fujikura (red) and SuperOX Japan (green) show distinct angular distributions (which are not easily parameterized) and possess similar critical currents at higher fields despite the difference in temperature. The critical current in this plot is calculated by converting the torque measured on a rotating platform to critical current flowing at the edge of a conductor according to the bean model.

Generation of ultra-high magnetic fields with REBCO CC relies heavily on detailed understanding of the  $I_c(B, T, \theta)$  of the conductor so that the local  $I_c$  margin throughout the magnet can be mapped. The large temperature and magnetic field ranges being considered for REBCO use requires a large dataset to be acquired for each conductor, as significant variation can exist within<sup>8</sup> a single manufacturer and especially between them depending on the synthesis method and pinning centre scheme. In the figure below, torque magnetometry was used to characterize CCs in a variety of high magnetic fields and temperatures, revealing a wide distribution of critical currents.
